**Flood Control Project Maintenance
Levee Inspections****LMA District Cover Sheet****Spring 2012 Levee Inspection Results****Reclamation District No. 1660 Tisdale**

Levee Inspection Report By Mile - Spring 2012

Reclamation District No. 1660 Tisdale

Waterway							Bank	Unit Miles	Inspection Start/End	Inspector
Unit No. 01 Sacramento River							Left	3.00	03/27/2012 03/27/2012	Bob Duffey
LMR No.	Levee Mile		Category	Item	Location	Rating	Action/Comment	GPS Latitude/Longitude		Issue No.
	Start	End						Start	End	Photo
1			Earthen Levee	Operations & Maintenance Manuals	LS	A Ma		°	°	13
								°	°	
DWR ID: DWR_RD1660_01_s_2012_13										
2			Earthen Levee	Emergency Supplies & Equipment	LS	A Ma		°	°	14
								°	°	
DWR ID: DWR_RD1660_01_s_2012_14										
3			Earthen Levee	Flood Preparedness & Training	LS	A Ma		°	°	15
								°	°	
DWR ID: DWR_RD1660_01_s_2012_15										
4	0.05	0.05	Earthen Levee	Encroachments	LS	M En	BU : Buildings	39.062643 °	39.062643 °	12
								-121.837857 °	-121.837857 °	Y
DWR ID: DWR_RD1660_01_s_2012_12										
5	0.08	0.10	Earthen Levee	Animal Control	LS	M Ma	A3 : No rodents visible, but rodent burrows visible; need to backfill and compact or grout burrow

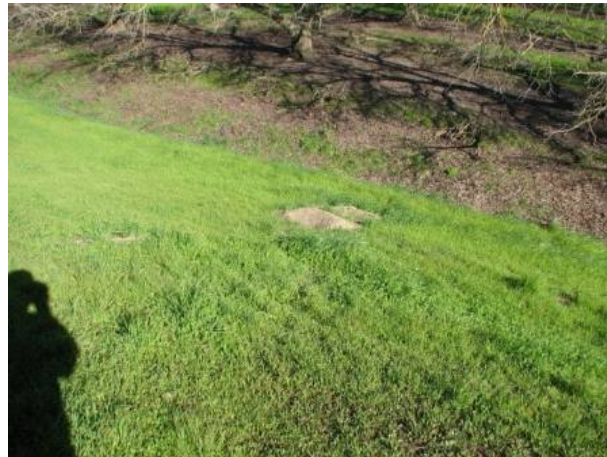
Levee Mile Report Line	5
Start Levee Mile	0.08
End Levee Mile	0.10
Location	Land Side
Category	Earthen Levee
Item	Animal Control

View of squirrel holes along the slope.

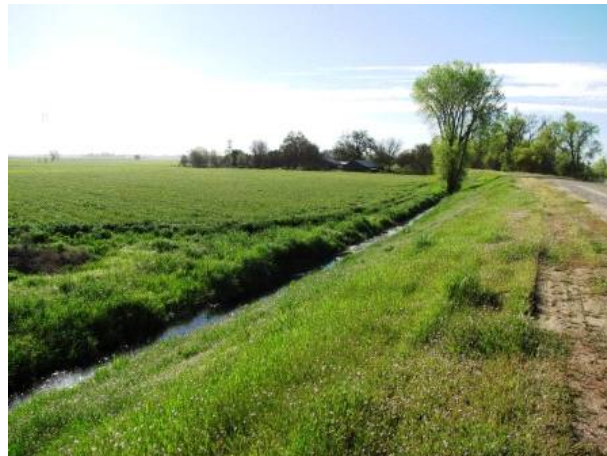
Levee Mile Report Line	6
Start Levee Mile	1.12
End Levee Mile	1.43
Location	Land Side
Category	Earthen Levee
Item	Encroachments

View of the AG ditch along the L/S toe.

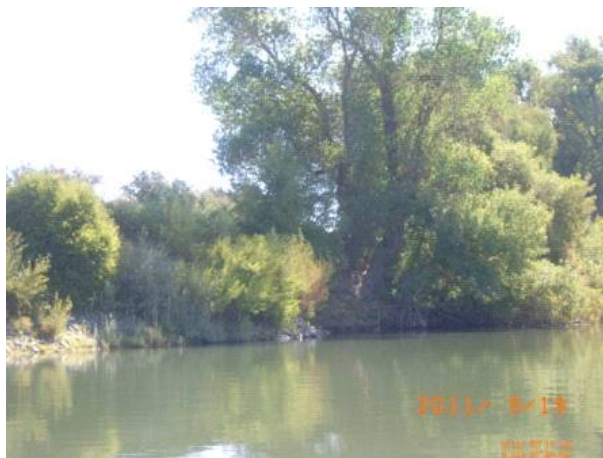
Levee Mile Report Line	7
Start Levee Mile	1.26
End Levee Mile	1.26
Location	Water Side
Category	Supplemental
Item	USACE Erosion Survey

USACE 2011 Photo #1

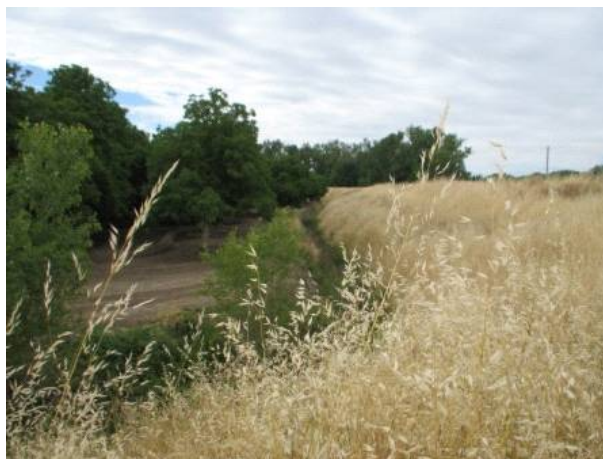
Levee Mile Report Line	8
Start Levee Mile	2.04
End Levee Mile	2.38
Location	Land Side
Category	Earthen Levee
Item	Encroachments

View of the large ditch along the landside toe.

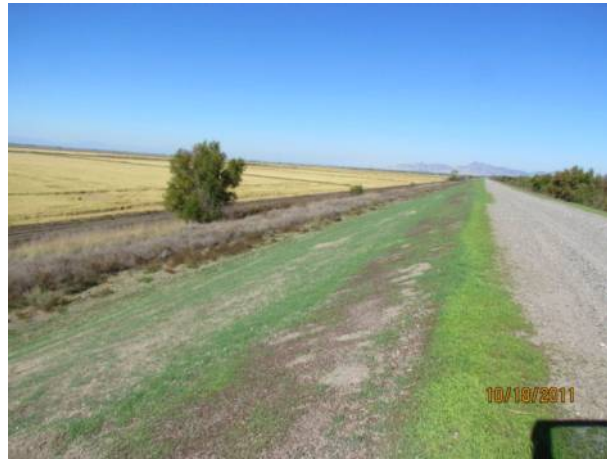
Levee Mile Report Line	4
Start Levee Mile	0.93
End Levee Mile	0.97
Location	Land Side
Category	Earthen Levee
Item	Animal Control

View of rodent holes along the L/S slope.

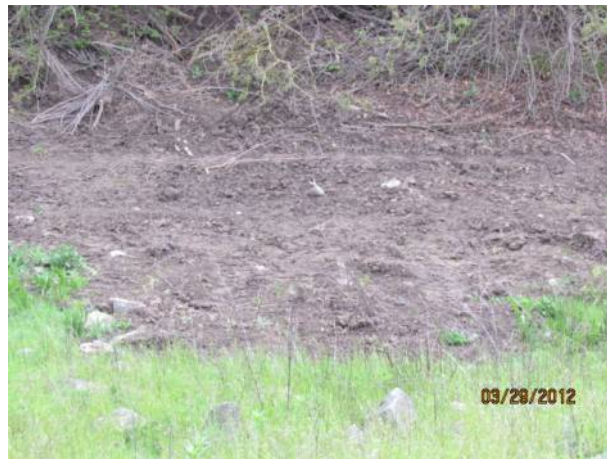
Levee Mile Report Line	5
Start Levee Mile	1.55
End Levee Mile	1.55
Location	Water Side
Category	Earthen Levee
Item	Animal Control

There were beaver holes at the toe of the levee that was repaired by the district.

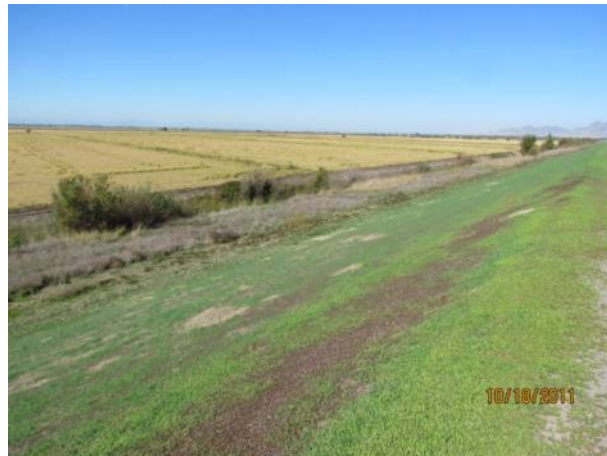
Levee Mile Report Line	6
Start Levee Mile	1.57
End Levee Mile	1.61
Location	Land Side
Category	Earthen Levee
Item	Animal Control

DWR ID: DWR_RD1660_02_s_2012_7										
6	1.57	1.61	Earthen Levee	Animal Control	LS	A Ma	A1 : Exterminate rodents and backfill and compact or grout burrows.	39.054595 ° -121.752460 °	39.055170 ° -121.752698 °	4 Y
DWR ID: DWR_RD1660_02_s_2012_4										
7	2.48	2.48	Earthen Levee	Animal Control	LS	C Ma	A3 : No rodents visible, but rodent burrows visible; need to backfill and compact or grout burrows.	39.067027 ° -121.757622 °	39.067027 ° -121.757622 °	5
DWR ID: DWR_RD1660_02_s_2012_5										
8	5.07	5.07	Earthen Levee	Animal Control	WS	A Ma	A3 : No rodents visible, but rodent burrows visible; need to backfill and compact or grout burrows.	39.102052 ° -121.774477 °	39.102052 ° -121.774477 °	6 Y
DWR ID: DWR_RD1660_02_s_2012_6

View of rodent holes along the L/S slope.

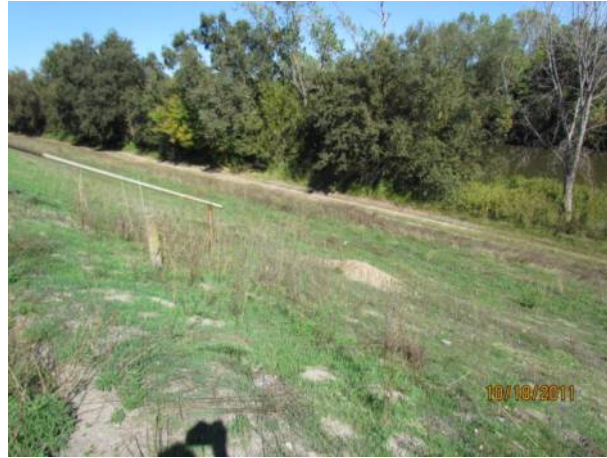
Levee Mile Report Line	8
Start Levee Mile	5.07
End Levee Mile	5.07
Location	Water Side
Category	Earthen Levee
Item	Animal Control

View of the rodent holes along the W/S slope.
